## ***Examples of Defects Found During Inspections.....***

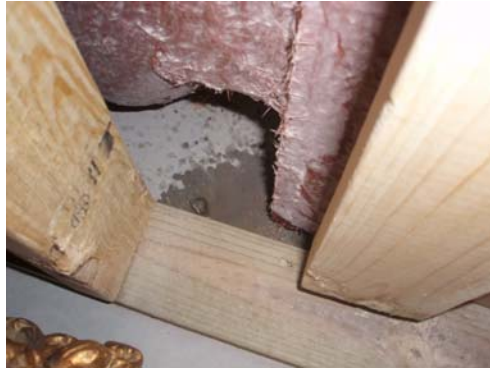
**The following picture shows a large leak coming from the back-side of a Shower wall. The Shower was installed improperly. This inspection was performed on a Brand New Home.**

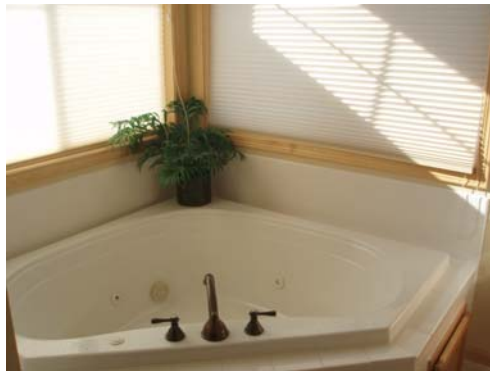
**The following picture illustrates a very common problem found in many homes. The windows surrounding the Jacuzzi tub are not “tempered”. If someone fell into the windows they would shatter into large pieces and could severely injure an individual. Not only that, but this is located on a 2<sup>nd</sup> level, a fall through a window from this height could also cause severe injury. This was found in a Brand New Home.**

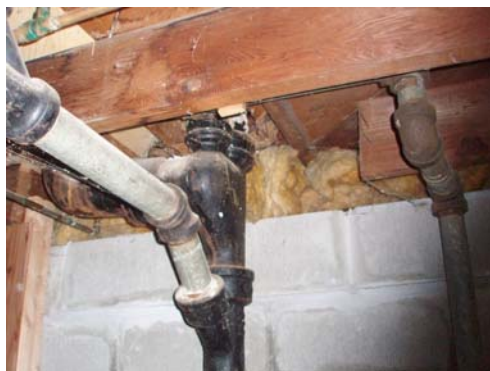
**The following picture shows a main support/ joist, cut away for the main plumbing lines to pass through. This can cause serious structural issues. The toilet main also leaked when the toilet was flushed.**

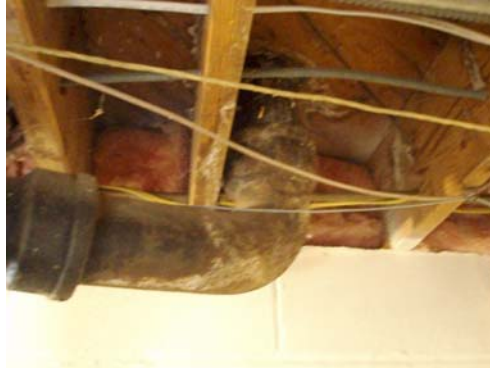
**The following picture shows a plumbing main which leaked when the toilet was flushed.**

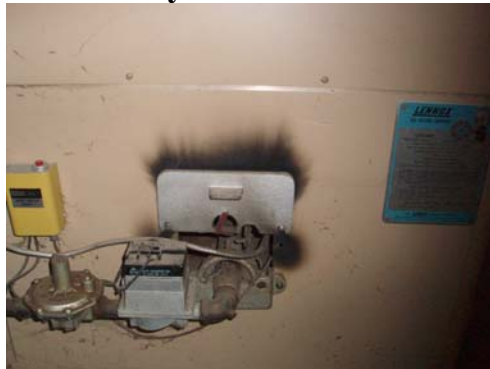
**The following picture is of an old HVAC unit with clear signs of past burner flame roll-out. This is a potentially dangerous situation and this unit needed further evaluation by a licensed HVAC contractor.**

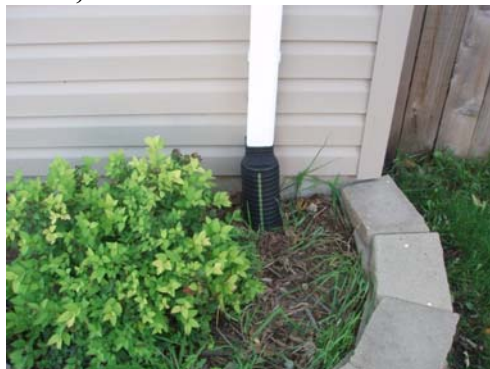
**The following picture shows a gutter that is run directly into the ground with no exit point. The home owner thought it would be a good idea to eliminate the gutters, there was no known drain field.**

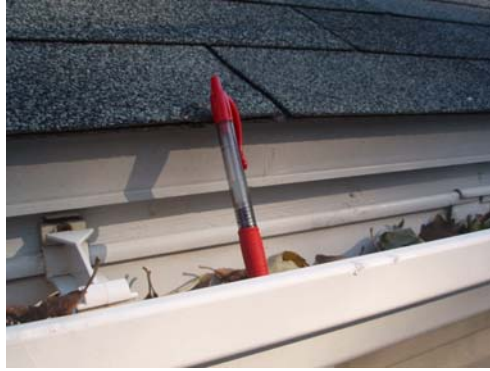
**The following picture shows a gutter system that was installed by a home owner. The gutters were brand new but were installed about 6-Inches below the roof line. Water would just over-shoot the gutters making them useless.**

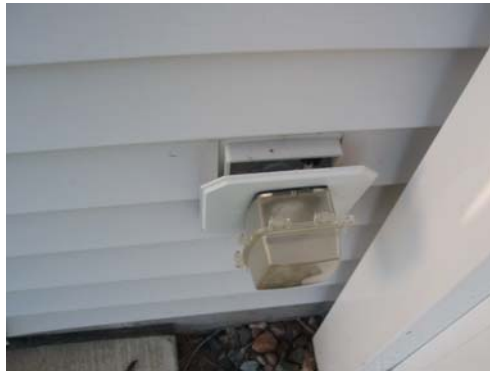
**The following picture shows an outdoor outlet hanging off a wall. This is a potential shock hazard. This was a Brand New Town Home.**

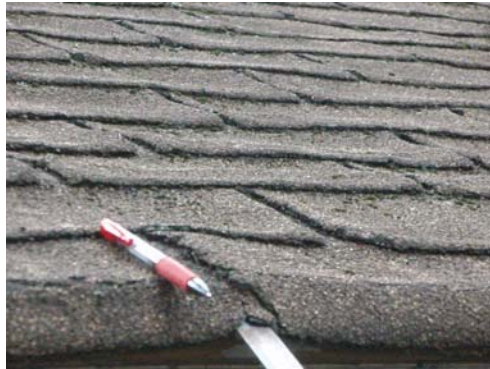
**The following picture shows a roof that has met its life expectancy.**

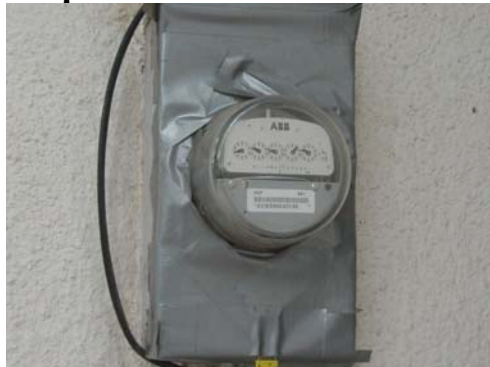
**The following picture shows an electrical meter that has a cover made of Duct tape. This is an electrical hazard.**
