Examples of Defects Found During Inspections.....

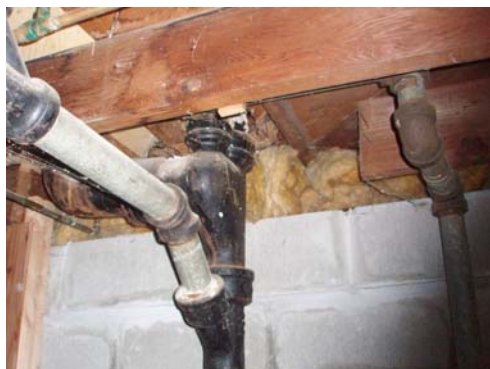
The following picture shows a main support/ joist, cut away for the main plumbing lines to pass through. This can cause serious structural issues. The toilet main also leaked when the toilet was flushed.
